**URBAN WATERSHED
RIPARIAN AREA HEALTH ASSESSMENT**

Ellen's Creek

Wright's Creek

January 2013

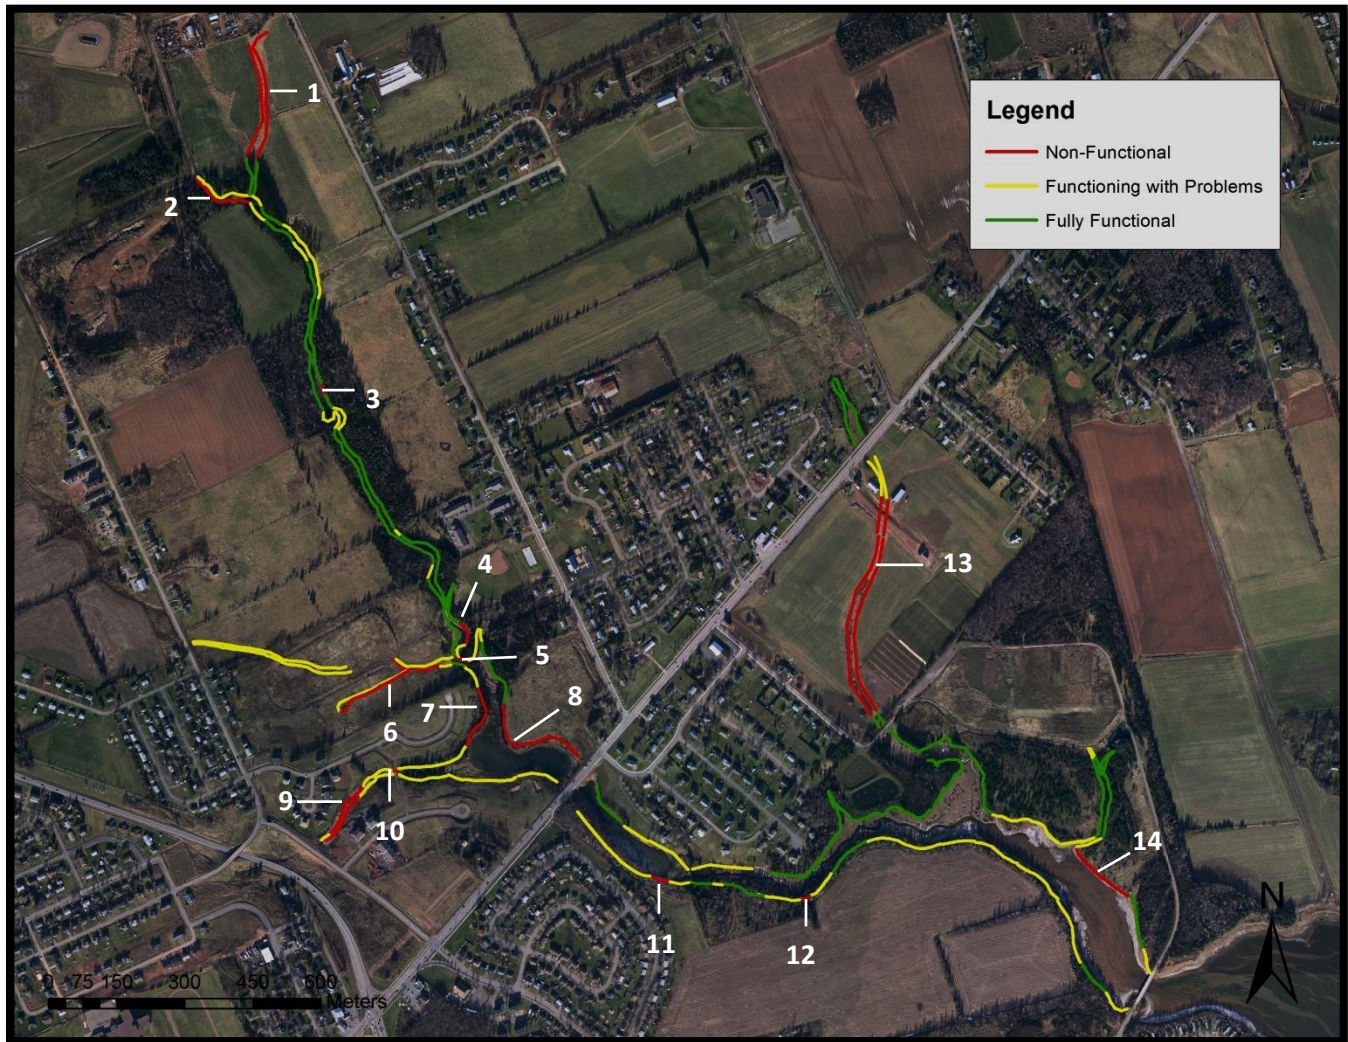
Figure 2. A map of Wright's Creek showing the degree of riparian area functionality.

Upon completion of the Riparian Area Health Assessment on Wright's Creek, a large portion of the riparian area was found to be functioning at a high or acceptable level. These numbers are correlated with the significant amount of woodland found along the watercourses. The northernmost branch of the stream flows through mixed coniferous/deciduous woods. In some sections, large Eastern Hemlock (*Tsuga canadensis*) and Yellow Birch (*Betula alleghaniensis*) grow along the stream banks. These species are indicative of remnant Acadian forest, which is rare to see within city limits. Several springs feed into the stream along this branch, which consistently scored above 80% (green), signifying optimal functionality in

these areas. The branch of the Wrights Creek found south of St Peters Road also exhibits a high level of functionality. Large hardwood trees including Red Oak (*Quercus rubra*) and American Beech (*Fagus grandifolia*) grow along the western side of this stretch. A popular walking trail is found here, which resulted in most of the stretch being scored in the second tier (60%-80% = yellow). This indicates the riparian zone is healthy, but has problems that may pose a risk to its functionality. The trail creates a compacted area of bare ground, which can result in excess runoff carrying sediment or contaminants into the stream. Large patches of Glossy Buckthorn (*Frangula alnus*), grow along the trail. This invasive plant has the potential to outcompete native species, which could pose a risk to riparian health. On the eastern side of this stretch, dense stands of White Spruce (*Picea glauca*) are found along the riparian area. The majority of this section was determined to be functioning properly, with no major risks present (>80% = green). Several stretches of Wrights Creek were flagged as being unhealthy and non-functional (<60% = red). For discussion purposes, these stretches were numbered from 1 to 14. Descriptions of each red zone, along with possible restorative actions are listed:

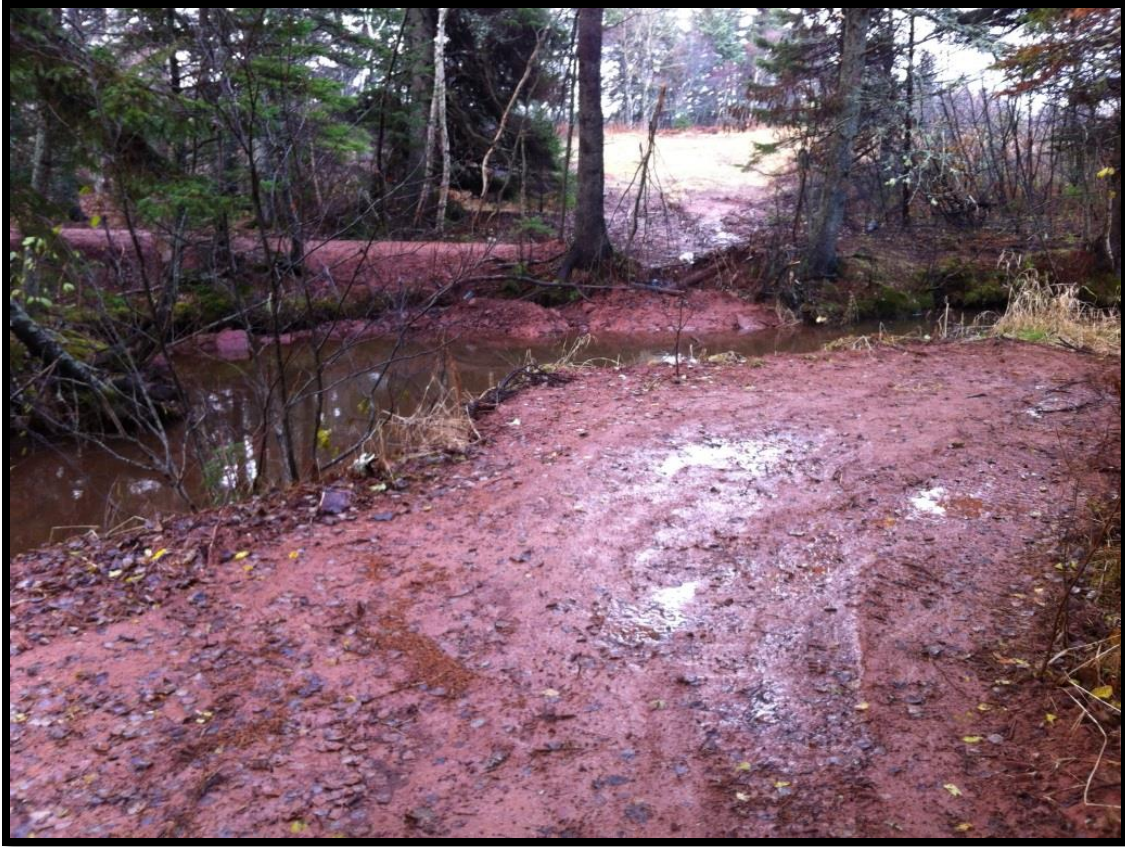
- 5- Red zone 5 is a short distance downstream from red zone 4, and exhibits the same riparian characteristics. It appears this area has been cleared during the recent stream alterations, exposing a large area of bare ground. Again, this exposed earth has no vegetation to help reduce sediment from entering the stream during rainfall. The stream flows faster here, and a high water event could cause substantial erosion of the stream banks. The riparian area is very dysfunctional, and the risk of damage to the stream is high. Heavy planting of trees and shrubs, and soil protection in the form of grass or mulch would be beneficial to this zone. For more immediate protection, hay bales, and silt fencing along the stream could be appropriate treatments.

Figure 3. A photo of red zone 5, a non-functional riparian area.

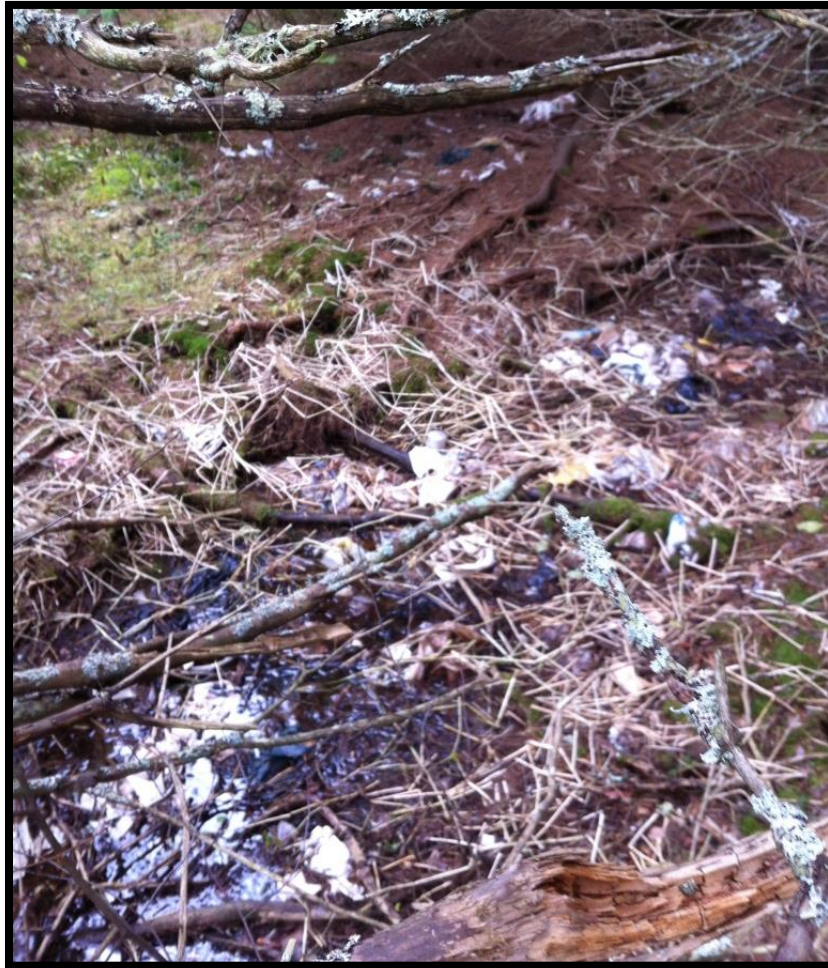
high quality water to the main branch. Further upstream, smaller springs also feed into the creek. Although siltation is a problem along most of Wright's Creek, this northern branch contains stretches where small stones and cobble line the stream bed. This provides suitable spawning locations for fish. Stream enhancement techniques aimed at controlling silt levels are improving spawning habitat. Such improvements to this branch, along with the recent restoration of Andrew's pond will create desirable conditions for fish, and other aquatic life. To the south of St. Peters Road, a small branch feeds the salt marsh from the east. It flows from the old landfill site near Robertson Road. A large amount of garbage, presumably remnants of the landfill, covers the streambed to the point of obstructing water flow. Although this tributary is very small, and volume of water is minimal, the excessive amount of garbage is concerning.

Figure 5. A photo of garbage along the stream bed near the old dump site.

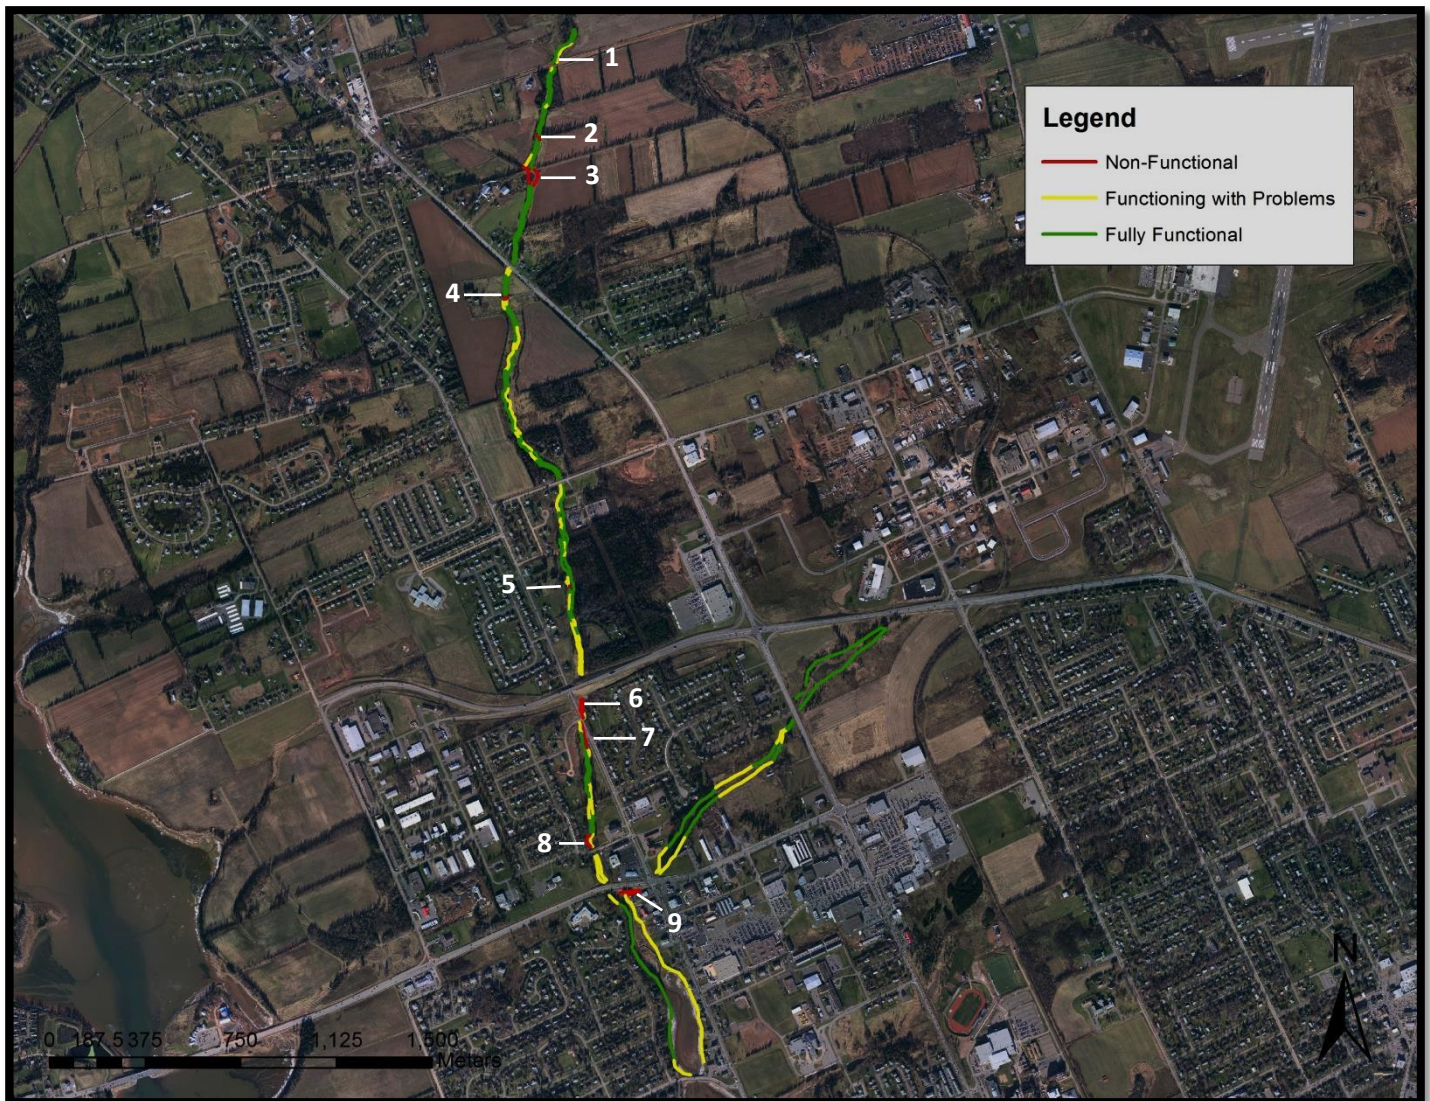
Figure 7. A map of Ellen's Creek displaying various degrees of riparian functionality

The results of the Riparian Area Health Assessment on Ellen's Creek show the majority of the riparian area to be functioning at an acceptable level. However, several 'red' areas were discovered. These non-functional zones are relatively small in length, but require action to prevent damage to the waterway. Some of the 'yellow' stretches along Ellen's Creek may also be treated as high risk due to their proximity to major commercial and residential development. This intensifies the risks to riparian functionality, and may require special attention in regards to upland management. In particular, the 'yellow' stretch on the east of the salt marsh may be considered high risk. The assessment results show the healthiest stretch of

riparian area in the watershed is found along the northernmost portion of the stream. North of Malpeque Road, the stream flows through a wooded buffer of desirable species (White Spruce, White Birch), resulting in mostly 'green' scores (>80%). Between Malpeque Road and the Charlottetown Bypass, riparian functionality alternates through 'green' and 'yellow' stretches. Residential properties border close to the stream at some locations along this section, which pose problems to riparian area functionality. Sections of mixed woods meet dense alder and cherry growth near the residential development. South of the Charlottetown Bypass, the riparian area becomes more fragmented in regards to wooded habitat. Although these areas may maintain functionality, they are at risk of becoming non-functional. The branch of Ellen's Creek found on the eastern side of the watershed exhibits an overall healthy riparian area. Potential risks were discovered near MacNeil's Pond and an old field north of here, where gaps in vegetation produced a 'yellow' score. A reforestation project on the northern side of this branch is improving riparian habitat. A description of the nine non-functional red zones found along Ellen's Creek, along with possible remediation strategies are detailed below:
