Macroinvertebrate sampling and water chemistry in Ellen's Creek

Prepared for
Ellen's Creek Watershed Group
and
Watershed Ecology 462, University of Prince Edward Island

Breanna Gardner
Paula Tummon Flynn
December 2, 2011

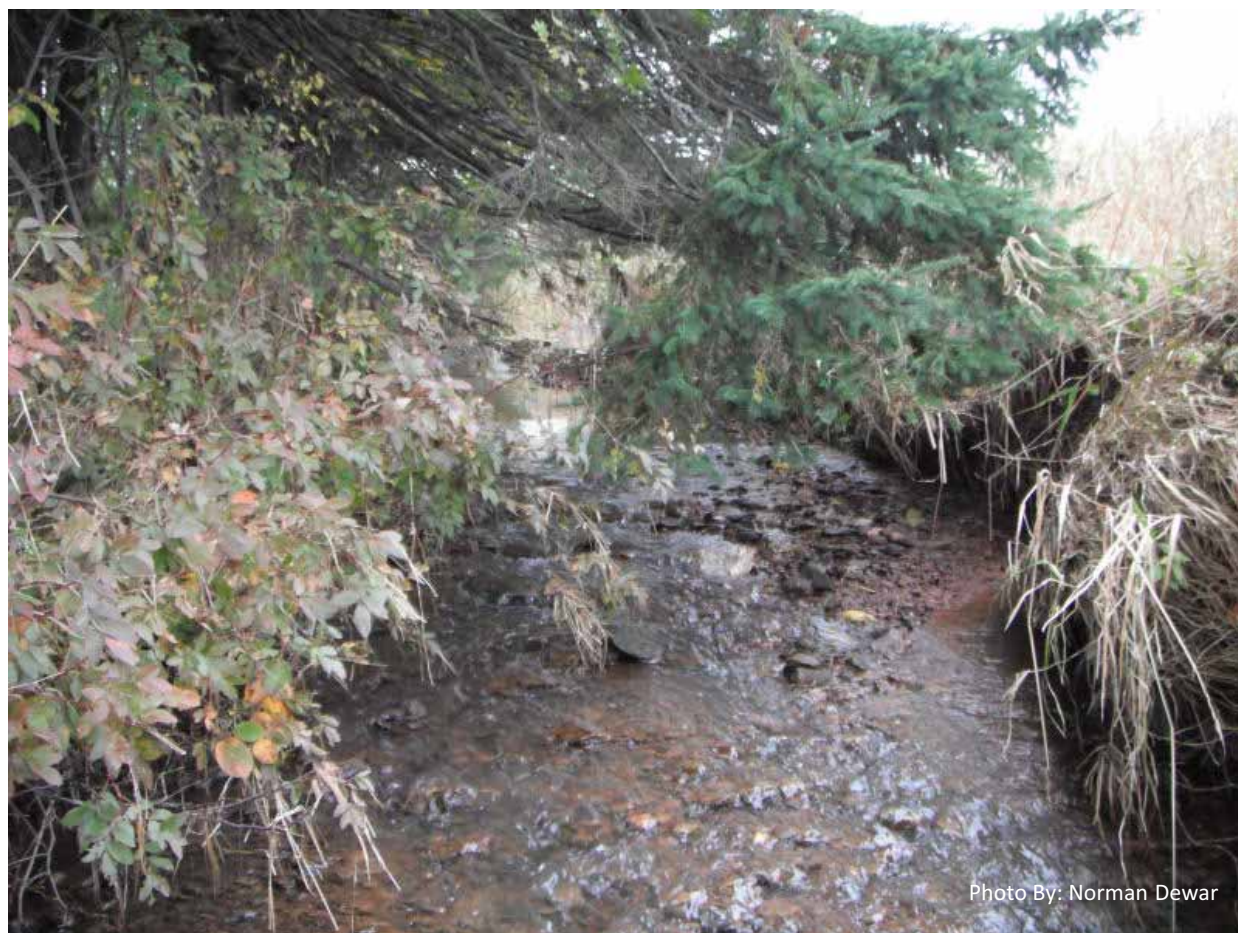
Figure 2. Upstream view of the eastern sample site in Ellen's Creek.

The East Branch flows from its source above the PEI Humane Society through an industrial/retail area (Norman Dewar, Ellen's Creek Watershed Coordinator, Personal Communication). The sample site on this branch (Figure 2) was located downstream of a pond and several heavily used roads (University Ave. and Trans-Canada Hwy.). There was a large

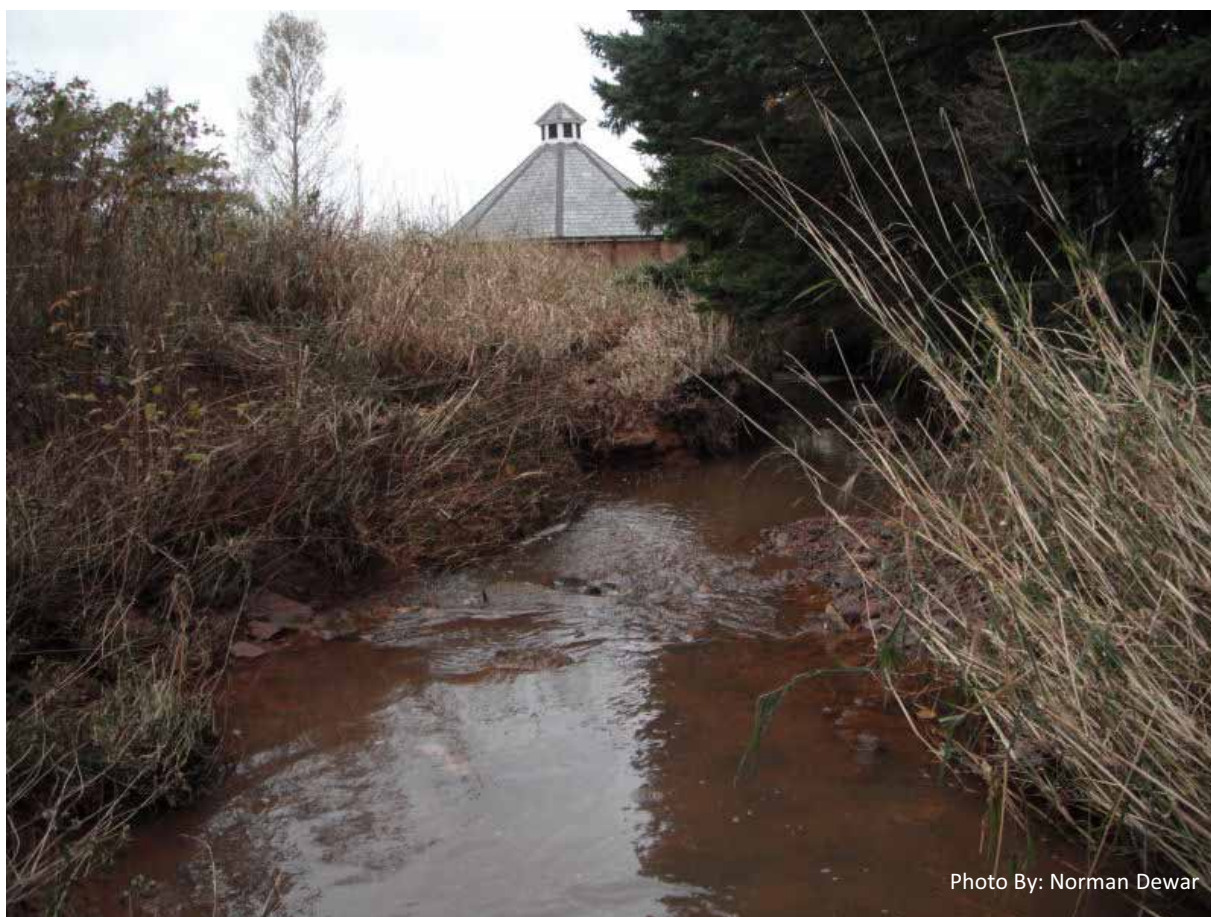
Figure 3. Downstream view of the eastern sample site in Ellen's Creek. There is grass along the southern bank and a row of trees along the northern bank.

culvert upstream (Figure 3) and another downstream of the sample site. Construction on a new mall had been occurring nearby at the time samples were taken and the Malpeque Road Water Pump station that is not currently in use was just adjacent to the sample site. The north bank of the site has a small row of trees that consists mainly of white spruce (*Picea glauca*) and short grass. Undercut portions on both the north and south banks were observed (Figure 4) and the streambed was moderately rocky.

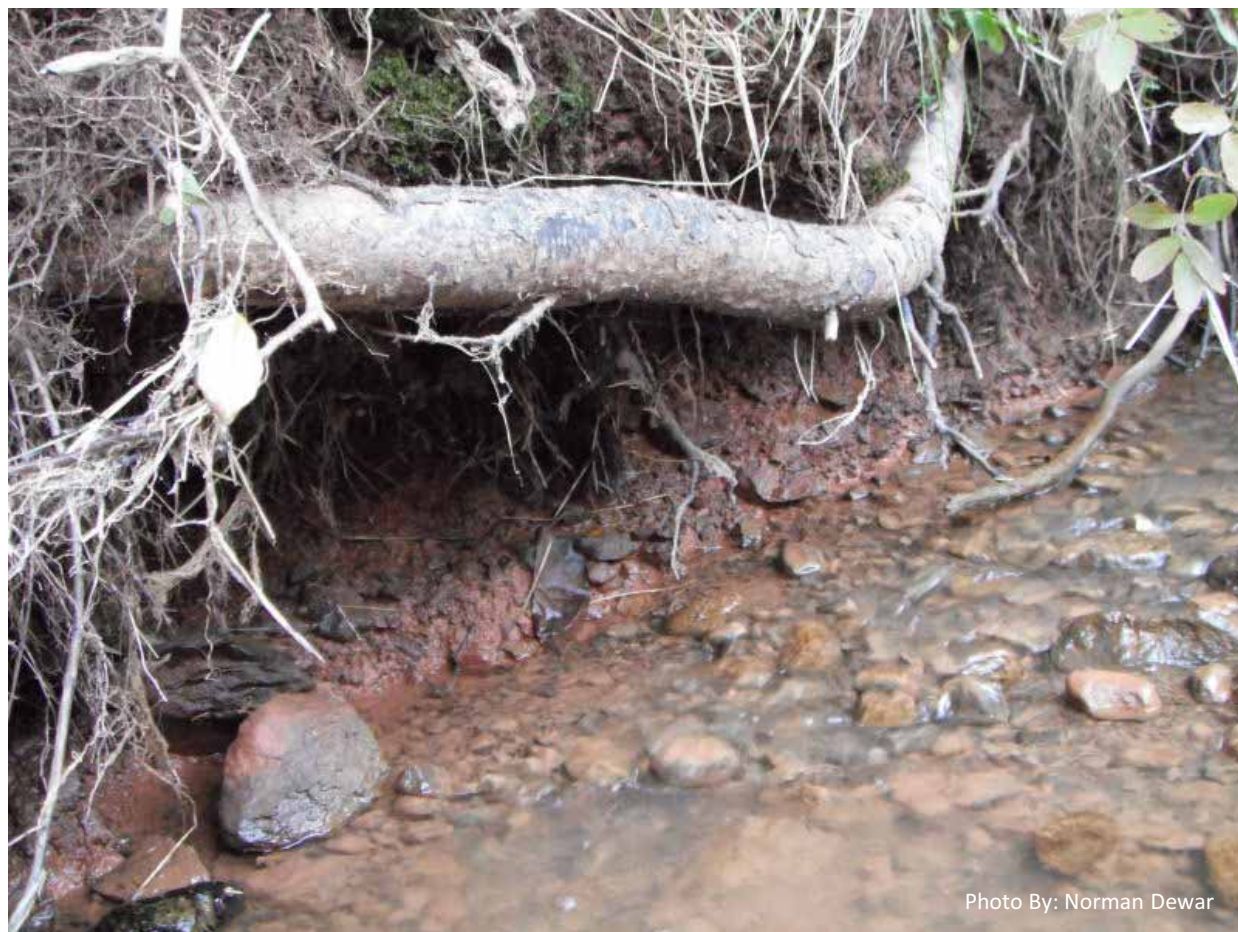
Figure 4. Undercutting along the north bank of the eastern sample site in Ellen's Creek.

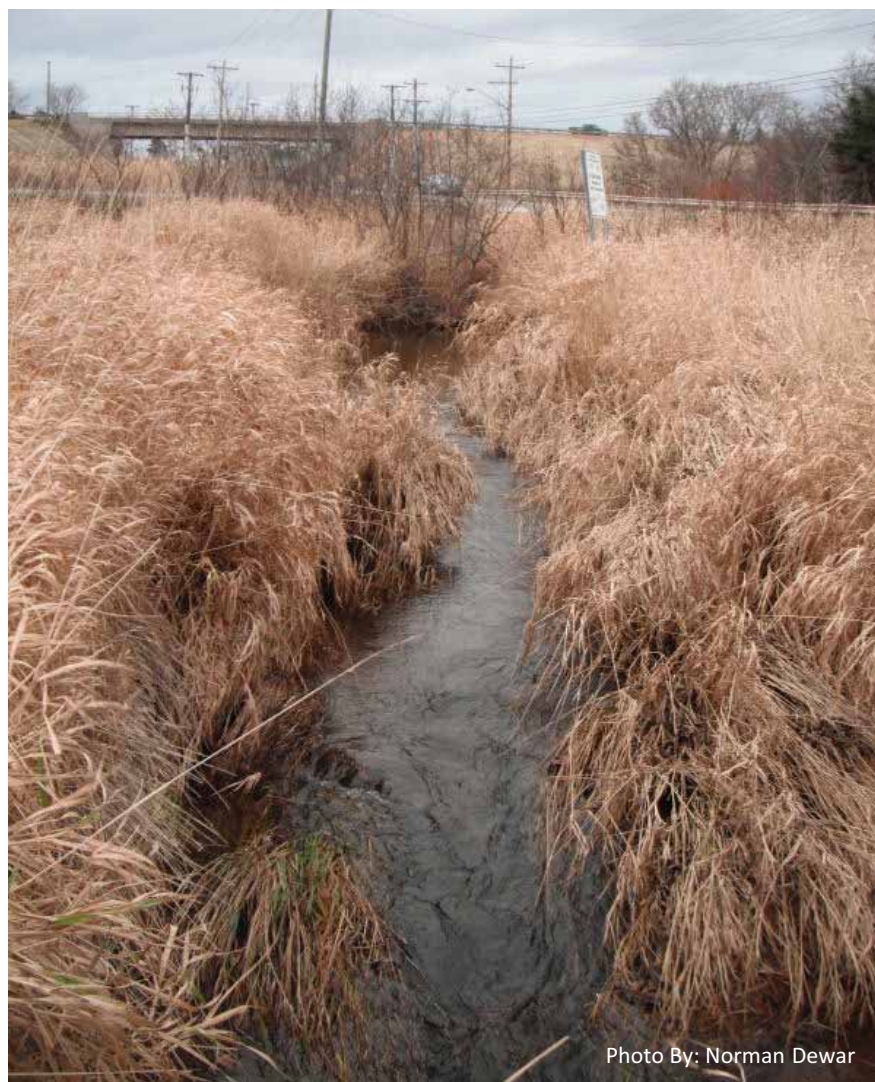
Figure 5. Upstream view at the western sample site in Ellen's Creek.

The West Branch flows from its source in Winsloe through small areas of agricultural land and forest, but mostly through urban housing and retail development (Norman Dewar, Ellen's Creek Watershed Coordinator, Personal Communication). Urban construction had occurred fairly recently uphill of the western bank at this site. There was a road (Lower Malpeque Rd.) 10 meters east of the sample site. A culvert that regularly has had high water levels (Norman Dewar, personal communication) is directly upstream of the sample site, while downstream there was a man-made pool. The banks consisted of long grass (Figure 5) and there was undercutting occurring along the banks (Figure 6). The bottom of the stream held a lot of silt at the sampling date and there was evidence of silt beginning to pile up along the banks.

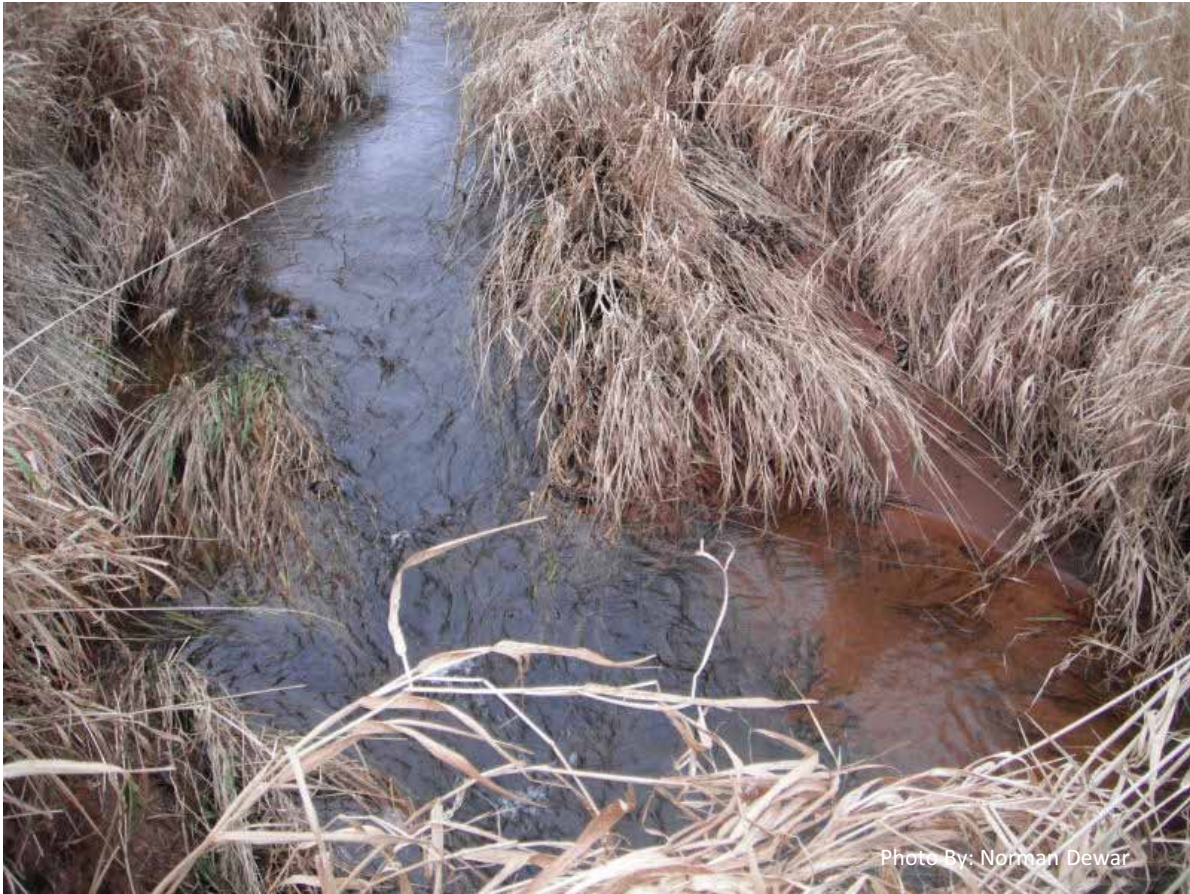
Figure 6. Sediment piling along the bank of the western sample site in Ellen's Creek.

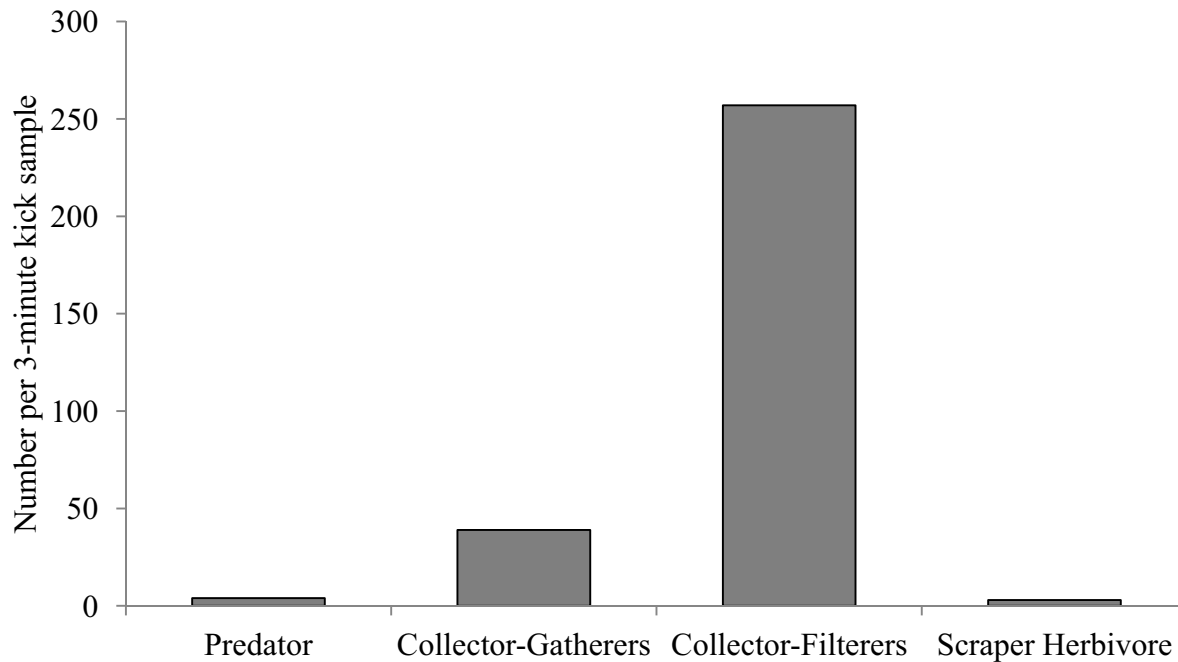
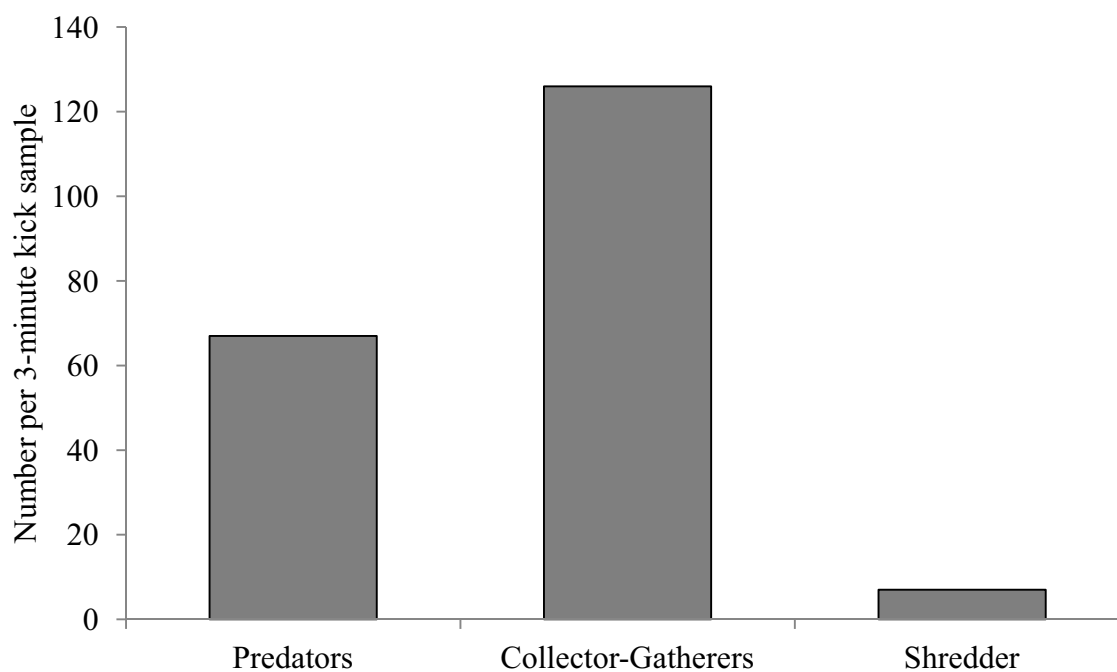
Figure 8. Trophic relationships of macro-invertebrates in the a) East Branch sample and b) West Branch sample of Ellen's Creek.

The macro-invertebrates found at each site had very different proportions of specific trophic relationships (functional feeding groups) as well as habits. In the eastern site (Figure 8a), the majority (85%) of the invertebrates sampled were collector-filterers, while smaller numbers of collector-gatherers, predators, and scraper herbivores were present. In the western site (Figure 8b), collector-gatherer invertebrates were found to be of the highest proportion (63%), while predators were also fairly abundant and there was a small number of shredding invertebrates. The habits of invertebrates also varied at the two sites. Most of the invertebrates found in the eastern sample site (Figure 9a) were considered clingers (87%). The western sample site (Figure 9b) was approximately half burrowers, and also included crawlers, clingers, and case makers.

Aquatic organisms can also be classified functionally by how they eat (Cummins 1974), and looking at the trophic relationships of invertebrates can reveal some elements of the habitat they live in. The functional feeding groups and habits of the invertebrates varied between the eastern and western sites of Ellen's Creek. The eastern sample site consisted primarily of

collector-filterers. Hydropsychidae (the most abundant collector-filterer in the sample) obtain food through a net or web made of silk. They collect and feed on suspended particulate organic matter that drifts from upstream (Georgian and Wallace 1981). These collector-filterers also tend to be clingers, which can attach themselves to a stable surface (Voshell 2002). High density of these filter feeders usually occurs in lake-outlet reaches (Richardson 1984) and the eastern sample was taken just downstream of a pond. The western site was in a free flowing stream and collector-gatherers and predators were found in high proportions. Collector-gatherers feed on detritus material that has sunk to the stream bottom and some, such as *Oligochaeta*, will burrow into sediment to feed, while others feed on the detritus that has fallen on the top of the sediment. The habit for these organisms is described as burrowers and crawlers. Burrowers live in sediment that is loosely compacted and densities of burrowers will increase with the amount of deposited sediment (Rabeni et al. 2005). The high proportion of burrowers in the western site reinforces the component of the habitat quality index which found a high amount of sedimentation in the West Branch of Ellen's Creek.

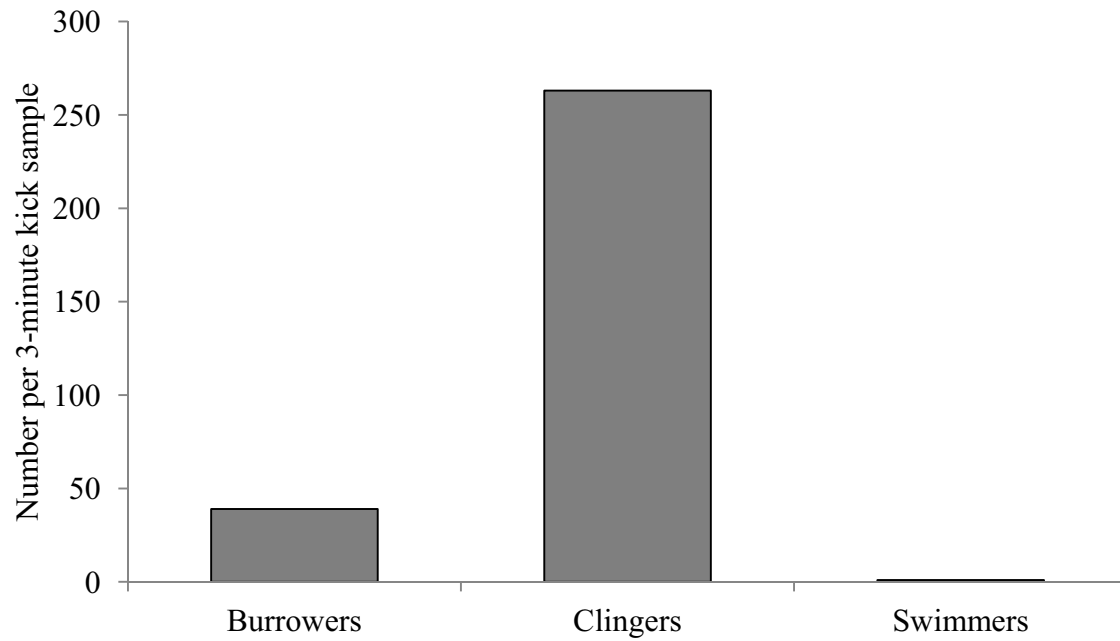
Figure 9. Habits of the invertebrates in the a) East Branch sample and b) West Branch sample of Ellen's Creek.
