**URBAN WATERSHED
RIPARIAN AREA HEALTH ASSESSMENT**

Ellen's Creek

Wright's Creek

January 2013

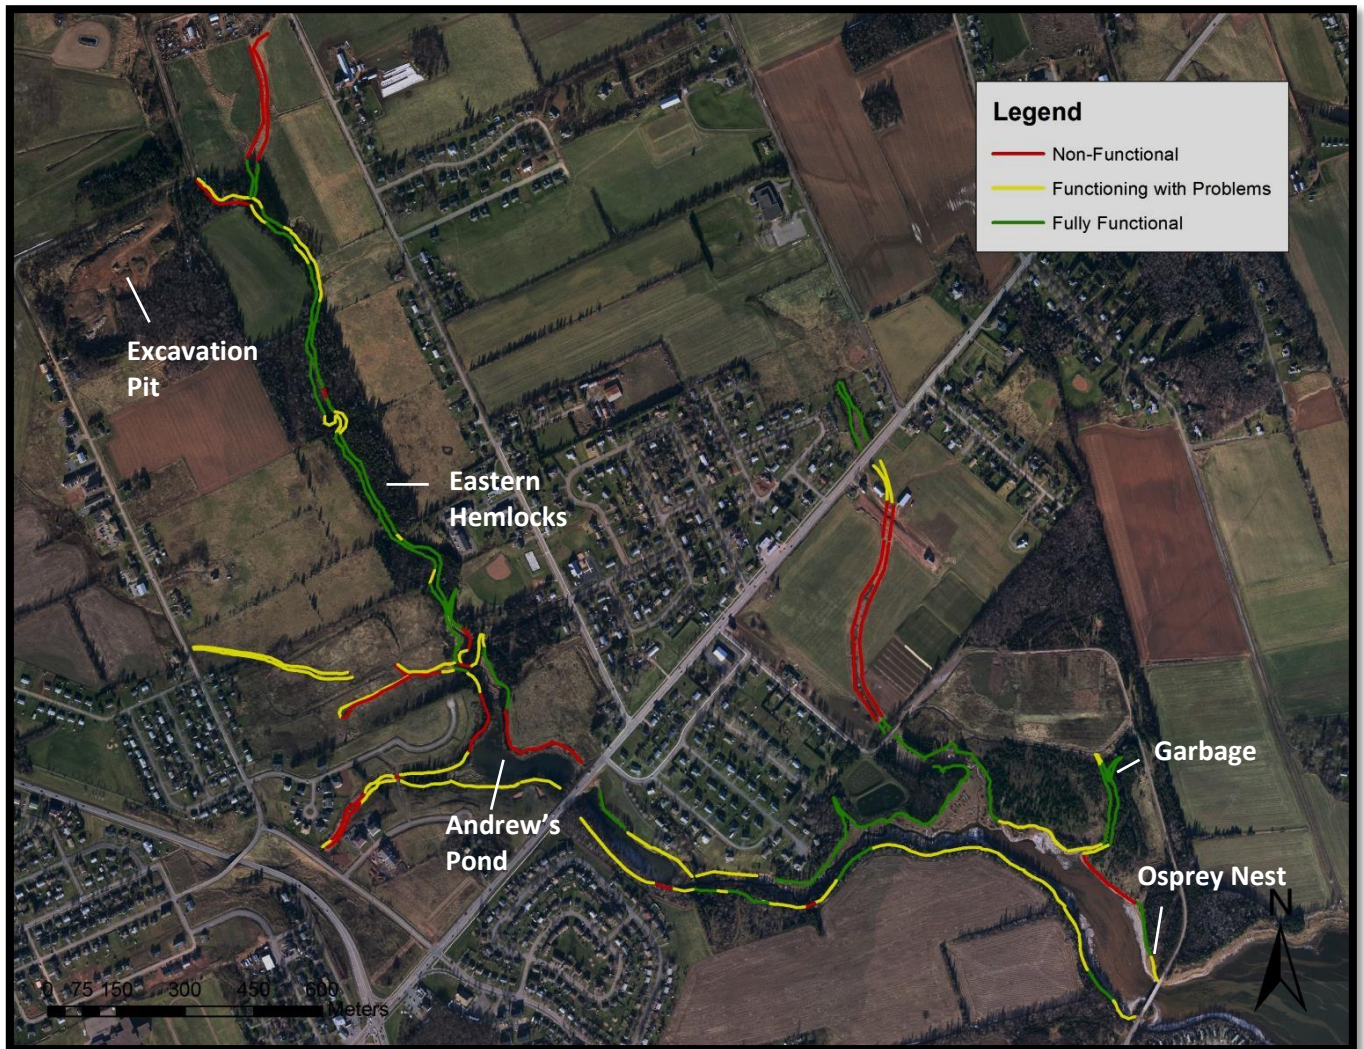
Figure 4. A map of Wright's Creek and notable features.

While conducting the Riparian Area Health Assessment, any notable observations relating to stream conditions, wildlife, and habitat were recorded. These are merely observations and have no bearing on the scores for riparian health.

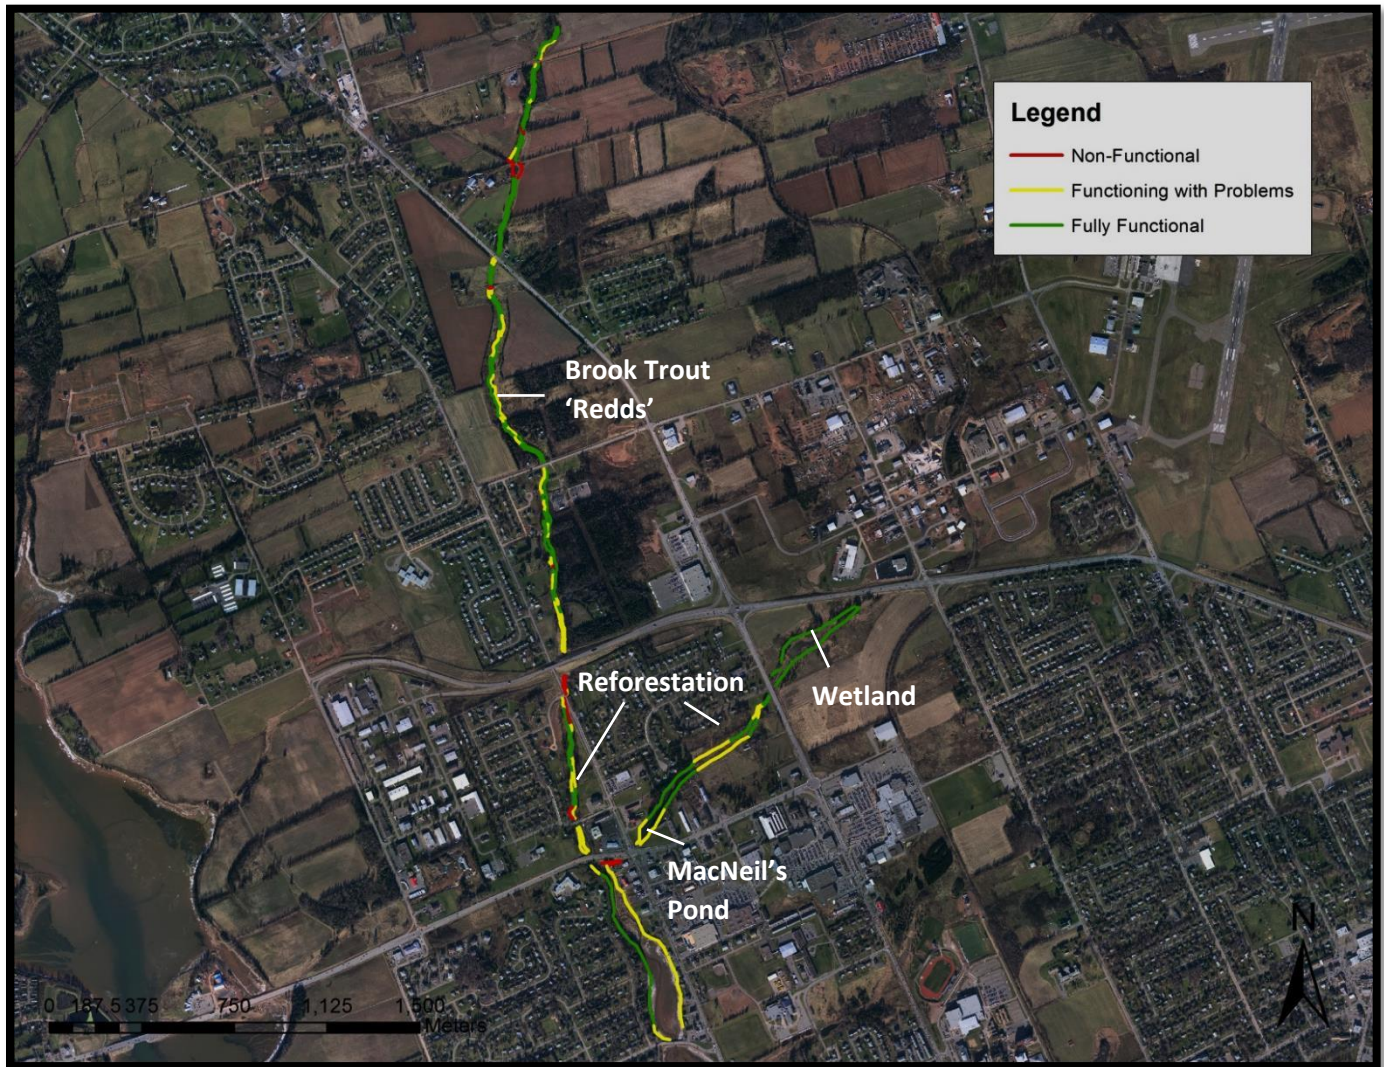
Figure 8 A map of Ellen's Creek with notable features labeled

While conducting the Riparian Area Health Assessment, any notable observations relating to stream conditions, wildlife, and habitat were recorded. These are merely observations and have no bearing on the scores for riparian health.
